# Manhole Inspection Summary

Manhole # S53M\_\_067MH

Insp Date: **4/3/08 11:13 AM**

**Location** Address: **3232 Dillon ODonnell**

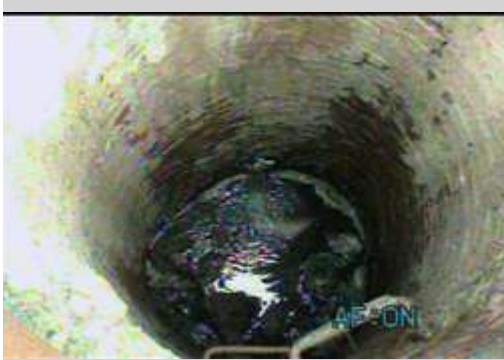
Defect 1

**Surcharge** ☒ **Evidence Of Surcharge** Depth: **1** (ft.) ☐ Active Surcharge Present

evidence of surcharge (from previous inspection visit)

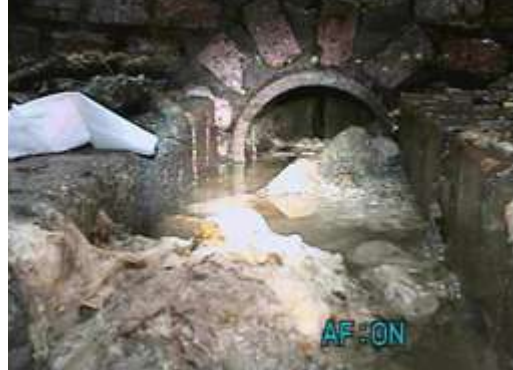
Defect 6

Condition: ☐ Sound ☐ Cracked ☐ Root Intrusion ☐ Deteriorated ☐ Leaks ☒ **Debris**

channel debris

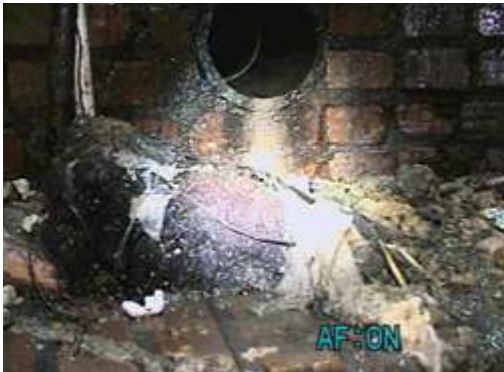
Defect 5

Infiltration: ☐ None ☐ Joint ☐ Cracks ☐ Mortar ☐ Roots ☒ **Wall**

Condition: ☐ Sound ☐ Cracked ☐ Root Intrusion ☐ Deteriorated ☐ Leaks ☒ **Debris**

bench debris (roots), infiltration in barrel wall

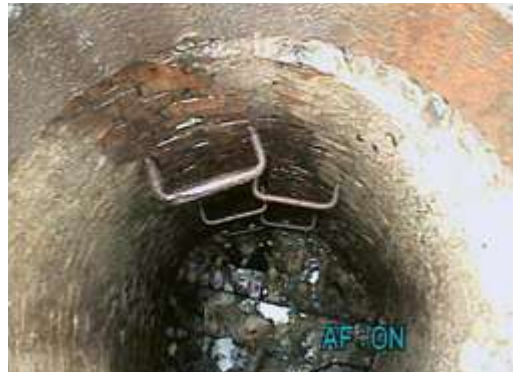
Defect 4

Infiltration: ☐ None ☒ **Joint** ☐ Cracks ☐ Mortar ☐ Roots ☐ Wall

**Steps** Count: **6** Missing: **0** ☒ **Corroded**

corr steps, infiltration from chimney/frame joint

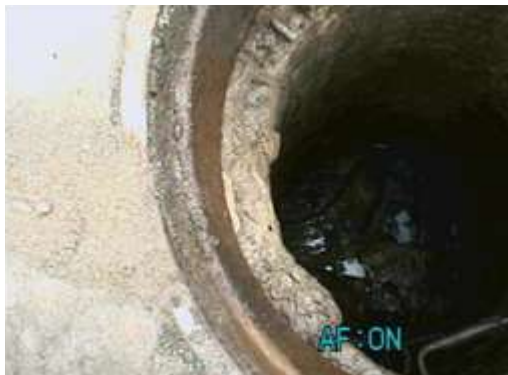
Defect 3

**Frame** Offset: **2** (in.) Condition: ☒ Sound ☐ Cracked ☐ Leaks

offset

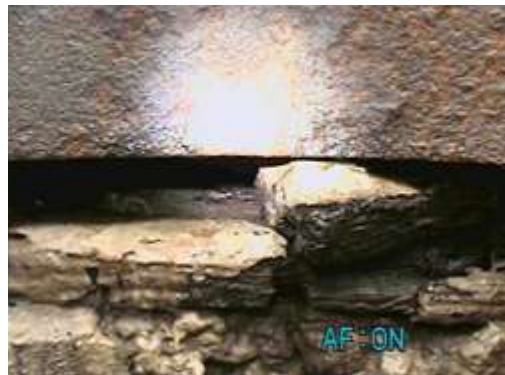
Defect 2

Condition: ☐ Sound ☐ Cracked ☐ Root Intrusion ☒ **Loose Brick** ☒ **Deteriorated**

frame adj loose bricks, deteriorated

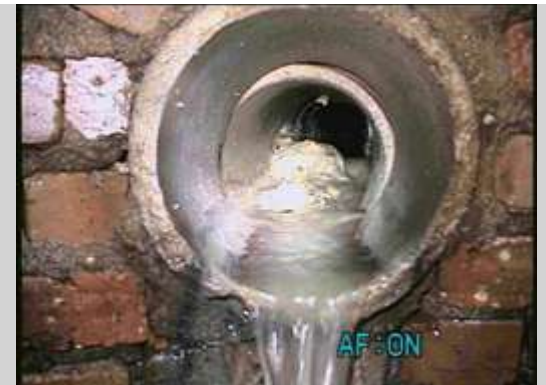
3 O'Clock Inflow

Deposits: ☐ None ☐ Mud ☐ Sludge ☒ Debris ☐ Grease

Silt Depth: 3 (in.) Deposits Extent: Light

Drop Condition: Clogged
